Static liquefaction as a possible explanation for the Merriespruit tailings dam failure

A.B. Fourie, G.E. Blight, and G. Papageorgiou

Abstract: In 1994 the Merriespruit gold tailings dam in South Africa failed, resulting in 17 deaths. The post-failure investigation provided no explanation as to why the catastrophic flow failure, which contradicted all previous experiences of failures of gold tailings dams in South Africa, occurred. The documented history of the dam describes insufficient freeboard provision and often poor pool control, which is argued to have resulted in some areas of the dam having high in situ void ratios. Some of the undrained triaxial tests carried out on specimens obtained from zones adjacent to the failure scar exhibited nondilative behaviour. Laboratory triaxial tests that were conducted on reconstituted specimens and are reported in a companion paper defined a series of steady state lines that were dependent on the particle-size distribution of the tailings. Void ratios obtained from undisturbed samples taken during the post-failure investigation are compared with these steady state lines and it is shown that an appreciable percentage of the specimens wer

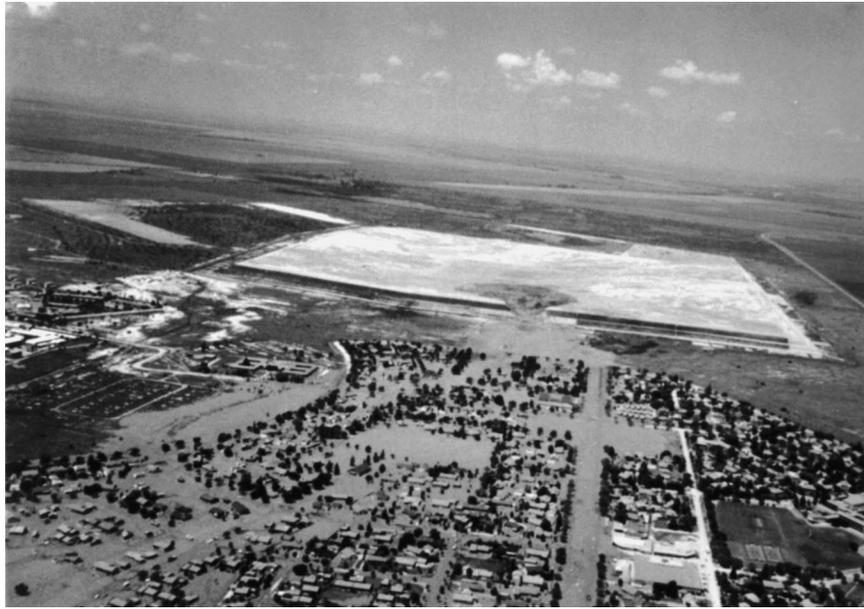
through the village of Merriespruit and finally stopped about 3 km downgradient of the tailings dam when it reached a small tributary of the Sand River which flows through the northern boundary of Virginia. An aerial view of the failure is shown in Fig. 1. As the first row of houses in Merriespruit were only some 300 m from the breach location, the wave of tailings was about 2.5 m high when it reached these houses. Many houses were swept off their foundations and others had walls demolished. Figure 2 shows two of the many houses that were destroyed. The maximum height of the tailings flow was clearly visible just below the eaves level. The failure occurred at 21:00 and, because many people were in their homes at this time, the number of fatalities was probably higher than would be the case if the failure occurred during daylight. A combined inquest-inquiry was presided over by a judge appointed by the Minister of Justice, and eventually both the mine and the contractor that operated the tailings impoundment were held responsible for the disaster.

Fig. 1. Aerial view of the Merriespruit tailings dam failure showing the path of the destructive mudflow that occurred.

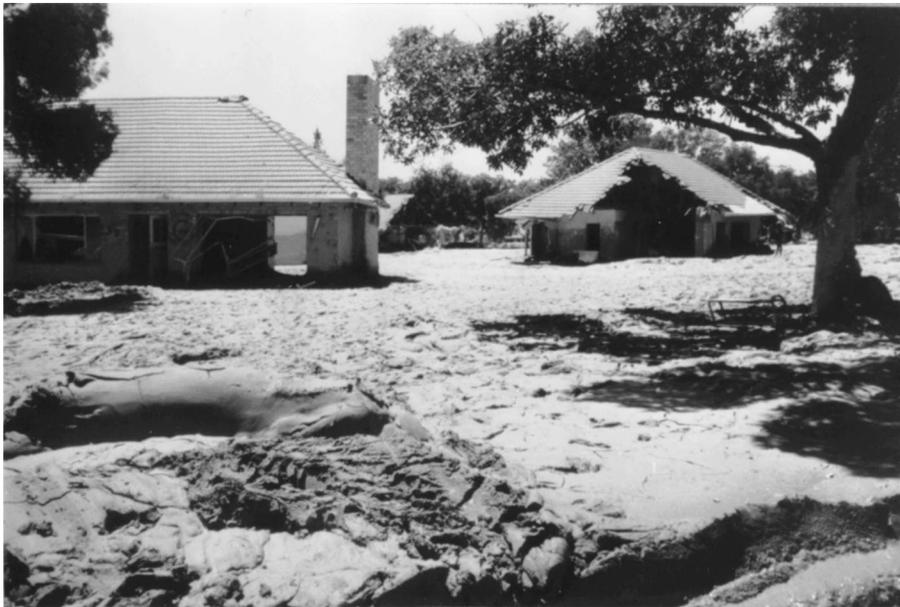
Fig. 2. Partially destroyed house that was about 350 m from the breach location.

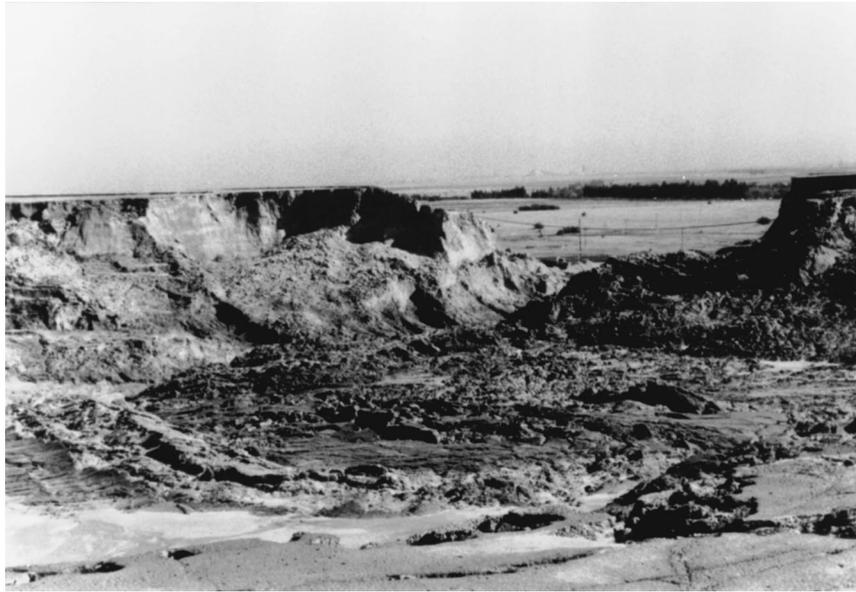
Figure 4 shows the sequence of retrogressive failures postulated by Wagener et al. (1998), based on eyewitness accounts of the Merriespruit disaster. The outer slope failed due to erosion by water overflowing from a small breach at the top of the slope. The slope became steepened locally and a sequence of slumping failures occurred because the shear strength was inadequate to maintain these steepened slopes. This slumped material was washed away by water escaping from the tailings pond. At some point it seems that this retrogressive failure exposed tailings that were in a metastable state in situ and instead of merely slumping, flowed as a liquid. This then appears to be the essential difference between the Merriespruit failure and other gold tailings dam failures in South Africa, where retrogressive failure of an outer slope has eventually stopped, either due to water from an exposed tailings pond being exhausted or the shear strength of exposed tailings eventually becoming sufficient to accommodate some localized oversteepening. This latter concept is illustrated in Fig. 5, which is a view of the Merriespruit

post-failure scar. The steep sides of the exposed tailings are clearly evident.

Fig. 5. View of post-failure scar from inside the failed area, showing the steep sides of the exposed tailings.

seeping from the sides of the newly exposed tailings surfaces (see the steep sides of the failure scar in Fig. 5). Although this may not have caused consolidation of the tailings, because it remained saturated, it would have the effect of reducing the pore-water pressure within the tailings, perhaps increasing the mean effective stress sufficiently to move the tailings away from a state of incipient failure. Although Strydom and Williams (1999) report relatively low in situ permeabilities of between 1 and 5 m/year, the hydraulic gradient induced by the retrogressive sequence of failures postulated by Wagener et al. (1998) in Fig. 4 would be high and

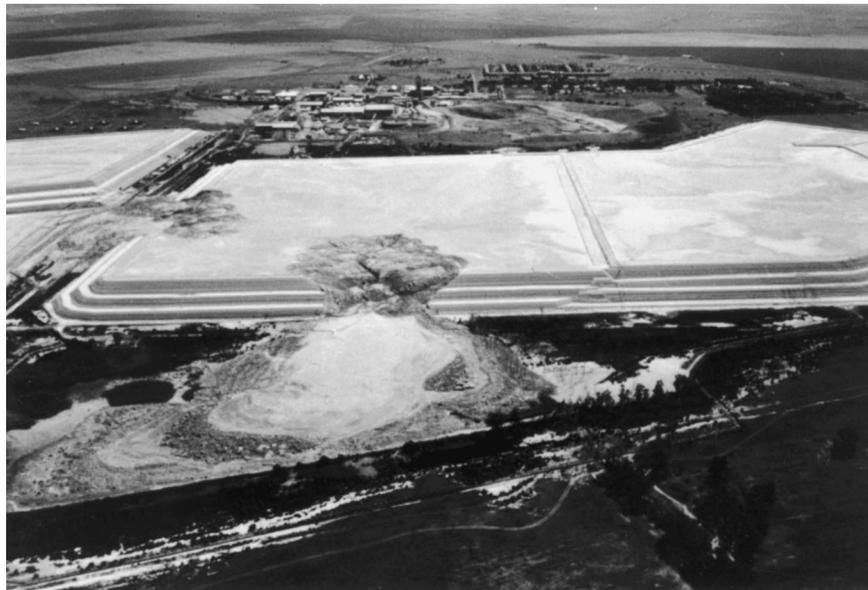
Fig. 6. Aerial view of two of the three failures that occurred at the Saaiploas tailings dam.

tioned earlier, the trigger for the flow slide was overtopping. The real question that remains is why, given an overtopping occurrence, did a large volume of tailings flow out of the dam? In 1992, three slope failures occurred at the nearby Saaiploas tailings dam. As shown in Fig. 6, none of these failures resulted in catastrophic flow slides, although in one instance the tailings did flow until halted by the wall of the return-water reservoir (Blight 1998). In the other two failures, the post-failure profile was typical of a slope instability, with steep back scarp and bulged toe. The tailings at the Saaiploas dam were essentially the same as those at Merriespruit, as was the deposition methodology. Why then were the two failures at one dam so localized and immobile,

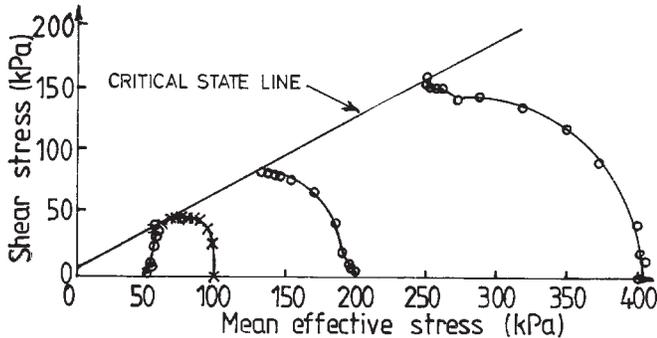
Fig. 7. Stress paths for consolidated–undrained triaxial tests on undisturbed specimens obtained from the Merriespruit tailings dam as part of the post-failure investigation (after Wagener et al. 1998). Axes are shear stress $t = (\sigma'_1 - \sigma'_3)/2$ and mean effective stress $s' = (\sigma'_1 + \sigma'_3)/2$.

four that is so typical of gold tailings in South Africa (Blight 1998), a few tests showed a slightly contractant response to loading. These results are shown in Fig. 7 in terms of a stress path plot using the parameters $s' = (\sigma'_1 + \sigma'_3)/2$ and $t = (\sigma'_1 - \sigma'_3)/2$, where σ'_1 and σ'_3 are the major and minor principal effective stresses, respectively (after Wagener et al. 1997). Although the stress paths do not show completely contractant behaviour, in that they do not move downwards and to the left after reaching a limiting shear stress (with commensurate post-peak softening in terms of shear stress against axial strain), there is no change to dilative behaviour either, despite axial strains of 20% being reached in these tests. Considering that these specimens were obtained from the section of the tailings dam that did not flow (but were in-

deed at the transition between flow and no-flow), it is not surprising that the specimens did not show pronounced strain softening. Although it is only conjecture, it is possible that the tailings that did flow were in a looser state than the specimens shown in Fig. 7 and thus exhibited truly contractive behaviour upon undrained shearing.

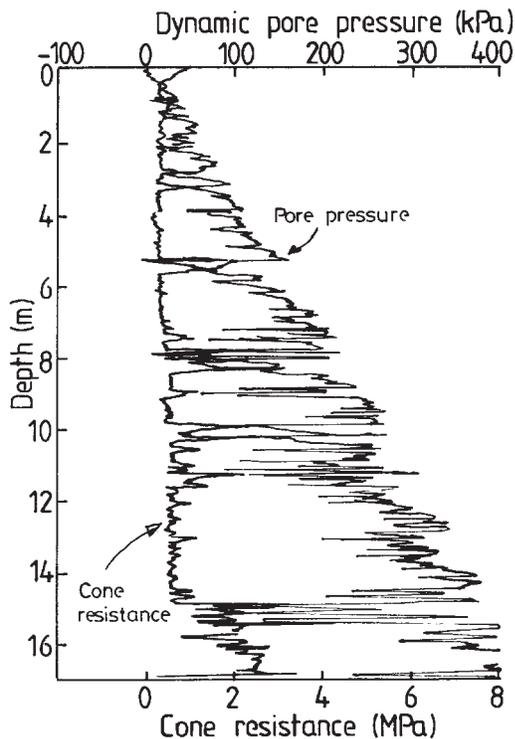
Fig. 8. Piezocone test result for test conducted adjacent to the decant facility (after Wagener et al. 1998).

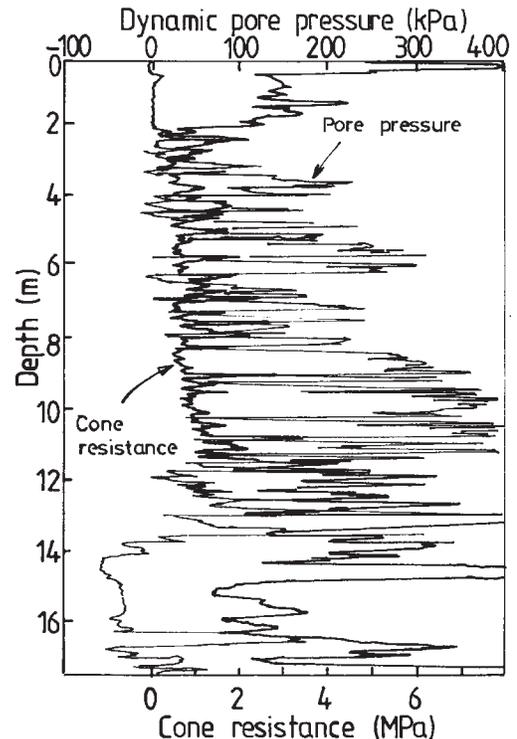
Fig. 9. Piezocone test result for test located west of the breach on the middle berm (after Wagener et al. 1998).

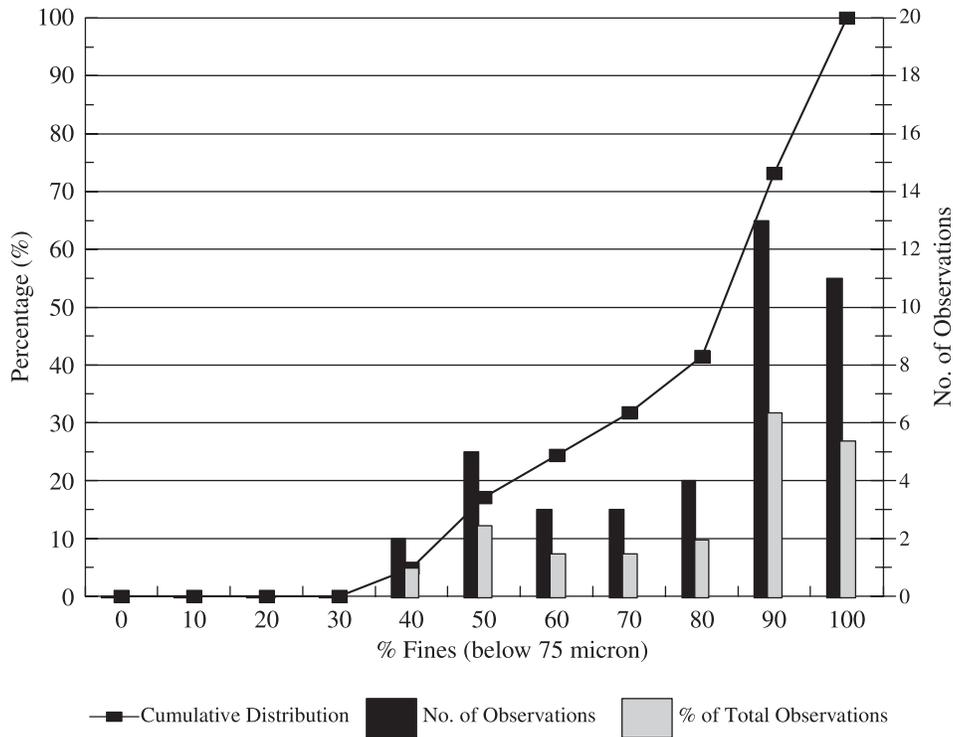
Fig. 10. Cumulative distribution of the Merriespruit tailings samples showing percent finer than 75 µm.

At the outset, it was recognised that it would be inadequate to determine an SSL for only one particle-size distribution of the tailings. Figure 10 shows a cumulative distribution of the Merriespruit tailings, gradings in terms of

the percent fines (<75 μm), obtained from particle-size distribution tests carried out on samples obtained at various locations around the failure scar during the post-failure investigation. Some samples have as much as 95% finer than 75 μm . In our tests, however, we decided to use a particle-size distribution with 60% finer than 75 μm as our finest tailings sample (M4). Three other particle-size distributions were tested, having 1%, 20%, and 30% less than 75 μm (designated M1, M2, and M3, respectively). The four tailings tested are shown in Fig. 11, and the SSLs that were obtained are shown in Fig. 12. The SSLs in Fig. 12 include an error allowance on void ratio of 0.05 to account for measurement errors during specimen preparation, as discussed by Fourie and Papageorgiou (2001). The results indicate that as the percentage of fines in the specimen increases, a higher relative density is necessary to ensure noncontractive behaviour during undrained shearing (Fourie and Papageorgiou 2001), although the 1 and 20% specimen SSLs are virtually indistinguishable.

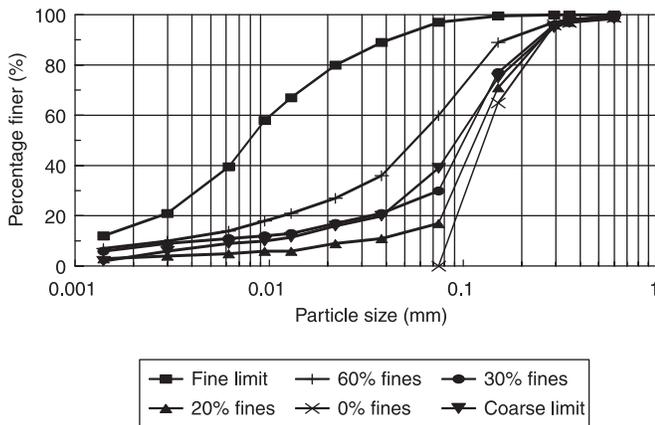
Fig. 11. Particle-size distribution curves for the four tailings samples tested.

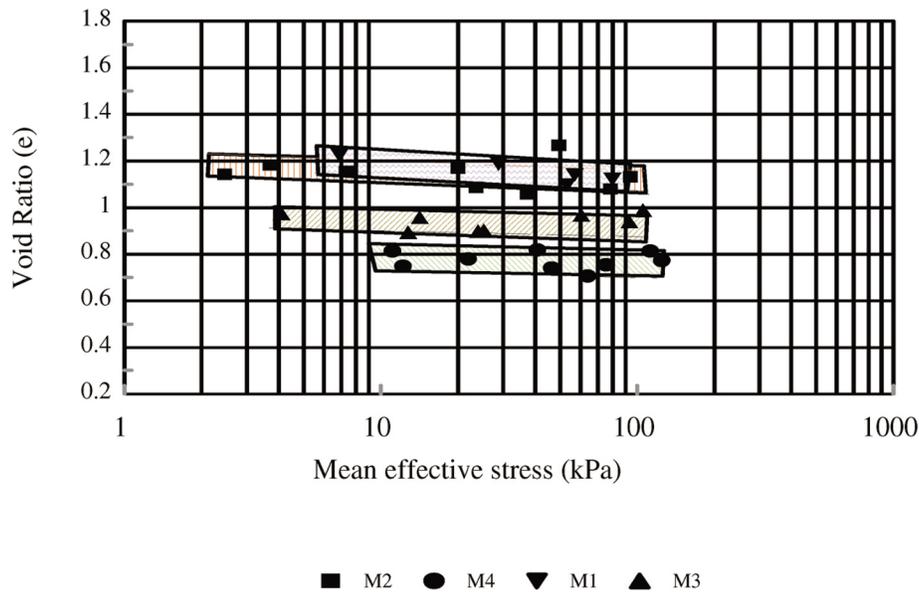
sample, this means that at 20% of the locations tested, the in situ void ratios plotted above any of the SSLs determined in this study. Although we did not determine the SSL for samples with more than 60% finer than 75 μm and, as shown in Fig. 10, a large percentage of the samples tested were in fact finer than this, the data in Fig. 12 indicate that as the percent fines increases, the SSL moves downward. Samples with more than 60% less than 75 μm would thus probably have an SSL below that of M4 in Fig. 12.

Fig. 12. The steady state lines obtained for Merriespruit tailings from undrained triaxial compression tests that showed contractive behaviour. The shaded areas represent an error allowance on void ratio of 0.05 either side of the steady state line.

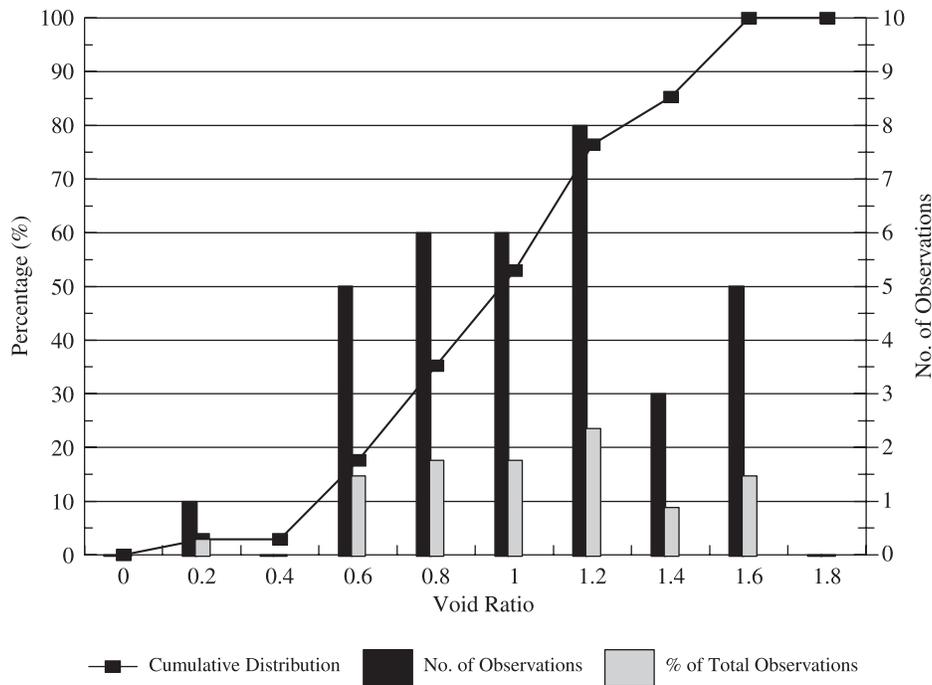
Figure 13 shows a cumulative distribution of in situ void ratios determined during the post-failure investigation. These void ratios were calculated from both Shelby tube samples recovered from depth at various locations around the dam and block samples taken from positions adjacent to the failure scar. Figure 13 shows that about 20% of the samples tested had void ratios of about 1.2 or higher. Bearing in mind that any disturbance of the samples during recovery would most likely result in a decrease in void ratio of the

The results discussed above can be used to estimate the likelihood that tailings adjacent to the failed mass could also have been in a “metastable” state and thus may have flowed if circumstances were conducive to this occurring. If tailings at a reasonable number of locations can be shown to have been in such a metastable state, then a convincing argument can be made for static liquefaction being the cause of the mass flow failure at Merriespruit. Figure 10 shows that about 75% of the 41 samples tested contained 60% or more fines. Using the SSL for M4 tailings shown in Fig. 12 and a mean effective stress of 50 kPa (equivalent to about 3 m depth for a deep phreatic surface), we are interested in in situ void ratios of greater than about 0.84 (i.e., $0.79 + 0.05$ as an error allowance), since this would place the in situ tailings above the upper envelope SSL for 60% fines tailings. From the results presented in Fig. 13 this was calculated to be about 61% of the measured void ratios.

Fig. 13. Cumulative distribution of in situ void ratios obtained during post-failure investigation.

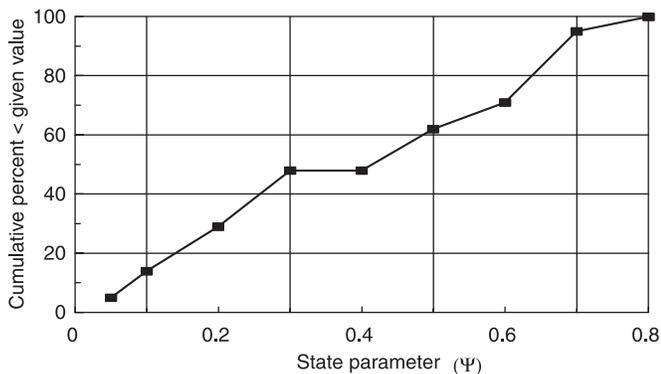
Been and Jefferies (1985) introduced the concept of the state parameter Ψ for describing the liquefaction susceptibility of a tailings or sand deposit. The parameter Ψ represents the difference between the in situ void ratio and the void ratio on the relevant SSL at the appropriate mean effective stress. A positive value of Ψ indicates specimens looser than the SSL and negative values of Ψ are obtained for specimens denser of the SSL. A cumulative distribution of Ψ values for the 21 samples that simultaneously satisfied both conditions is shown in Fig. 14. More than 85% of the samples have Ψ values of 0.1 or greater, i.e., a difference between the in situ void ratio and the equivalent value on the SSL of 0.1 or more. This represents a compelling argument in favour of the proposition that at the time of the failure a sufficiently sizeable proportion of the Merriespruit tailings was in a metastable state in situ and potentially liquefiable.

Fig. 14. Cumulative distribution of state parameter Ψ for undisturbed tailings samples obtained during post-failure investigation.
